TOWNSHIP OF MARLBORO
STREETS MAP
Municipal Code: 1328

SITES LISTS AND MAPS

MARLBORO VILLAGE DISTRICT 1328-1

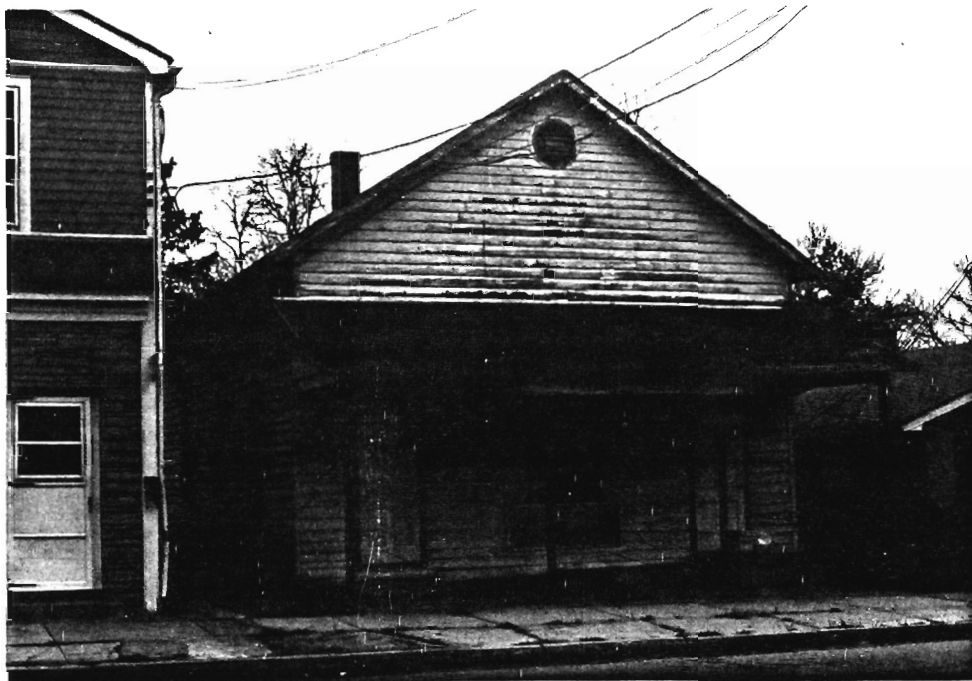
1328-1-1

Marlboro Township Hall

Late 19th c. frame building. 1 story, 3 bay by 3 bay form. Gable roof with internal rear wall chimney. Clapboard siding. 4/4 sash windows. Two doorways with 6 panel doors. Brick foundation with concrete veneer. Shed roof porch supported by metal posts. Building served as Marlboro Township Hall from 1890's to 1960's.

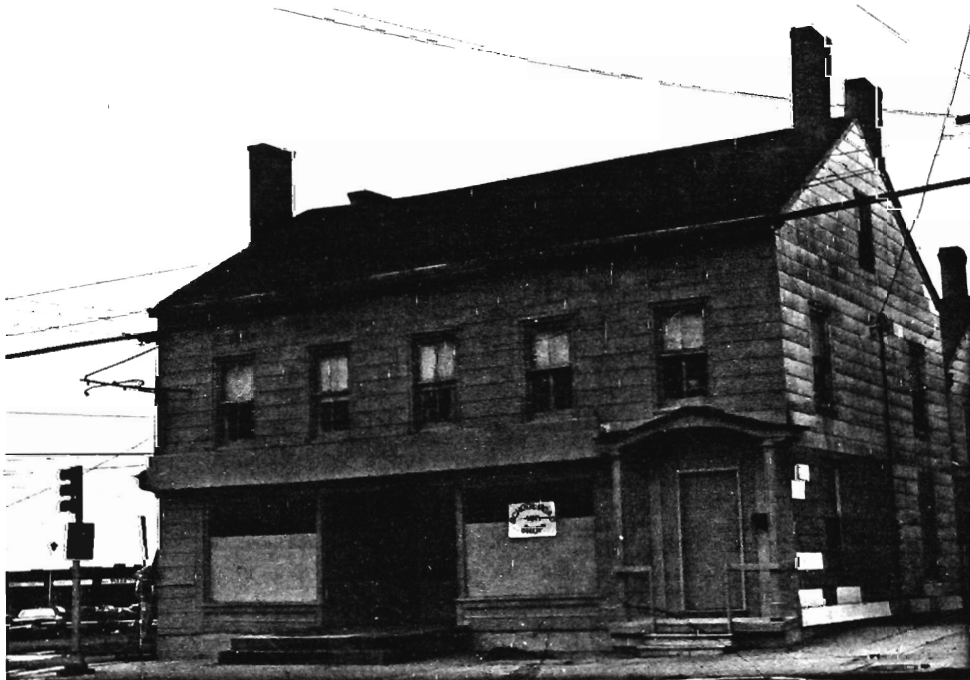
1328-1-2

Marlborough Hotel

1845 frame building with Federal elements. 2½ story, 5 bay form. Gable roof with narrow eaves and a box cornice. Two sets of twin end wall chimneys. Asbestos shingle siding. 2/2 sash in 2nd floor windows, 3rd floor knee wall windows shuttered closed, 1st floor windows replaced by 20th century storefront. 2nd doorway is under low pitched gable portico. Concrete veneer on foundation. Built 1845 by Uriah Smalley, later kept by John I. Sutphin, Gordon Sanford, William Applegate, William Church, Capt. James Stone, G.V. Carson, J. Atkinson and others. Later used as bank sweet shop, and meat and fish market.

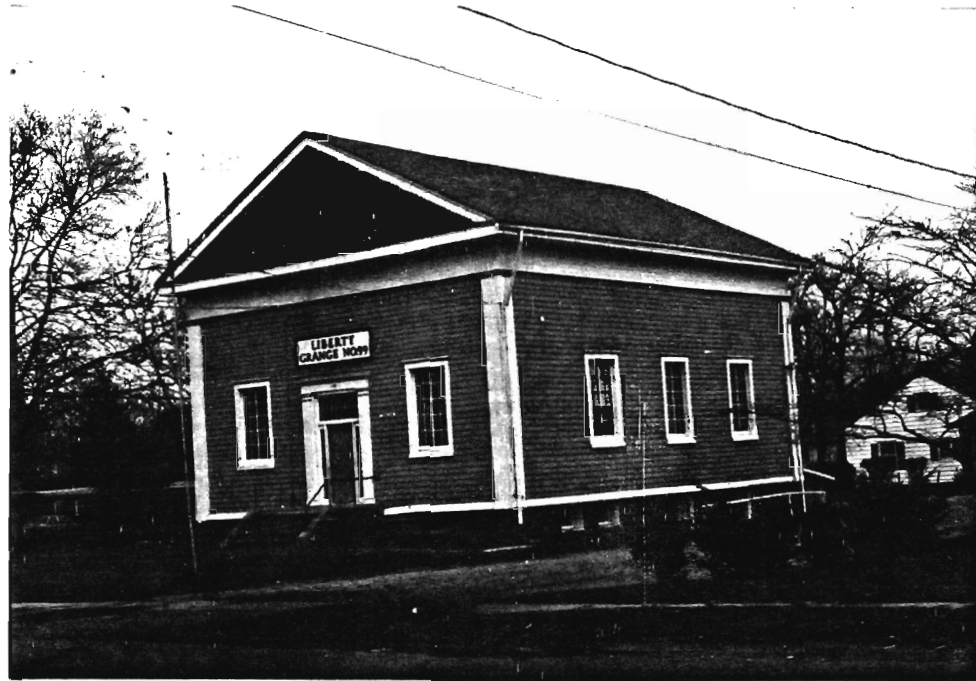
1328-1-3

Marlborough Baptist Church/Liberty Grange No. 99

SE cr. N. Main St and Vanderburg Rd.; Block 94, Lot 8; Marlboro Quad; Neg. File # 3-38*
1866 frame Greek Revival Church building. 1 story, 3 bay by 3 bay rectangular form. Moderately pitched gable roof, pediment, entablature, and smooth Doric order pilasters create temple form. Clapboard siding. 20 light windows have been reduced in size from the top. Doorway has Greek Revival enframing with sidelights and a large transom light. Replacement door. Brick foundation. Building was sold by Baptist congregation to Grange in the 1930's.

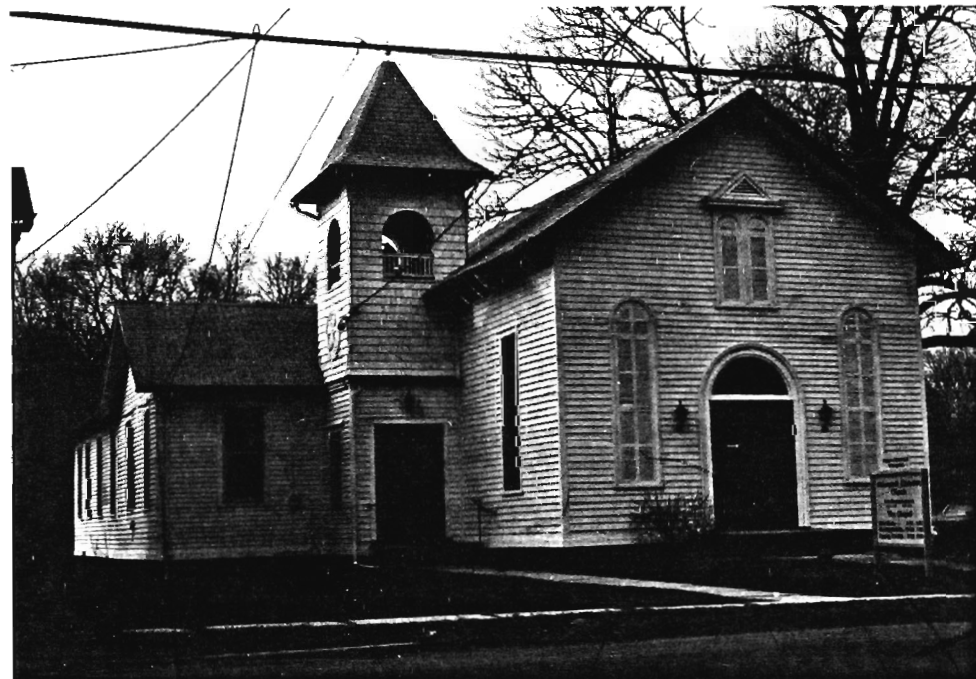
1328-1-4

Marlborough Dutch Reformed Chapel/Monmouth County Christian Church

1869 frame vernacular Victorian church with Romanesque elements. 1½ story, 5 bay asymmetrical form. Intersecting gable roof with pyramidal roof on bell tower. Round headed windows front facade, rectangular windows on side. Clapboard siding. Semi-circular transom surmounts front double doorway. Brick foundation. Chapel was part of Old Brick Church (1328-10).

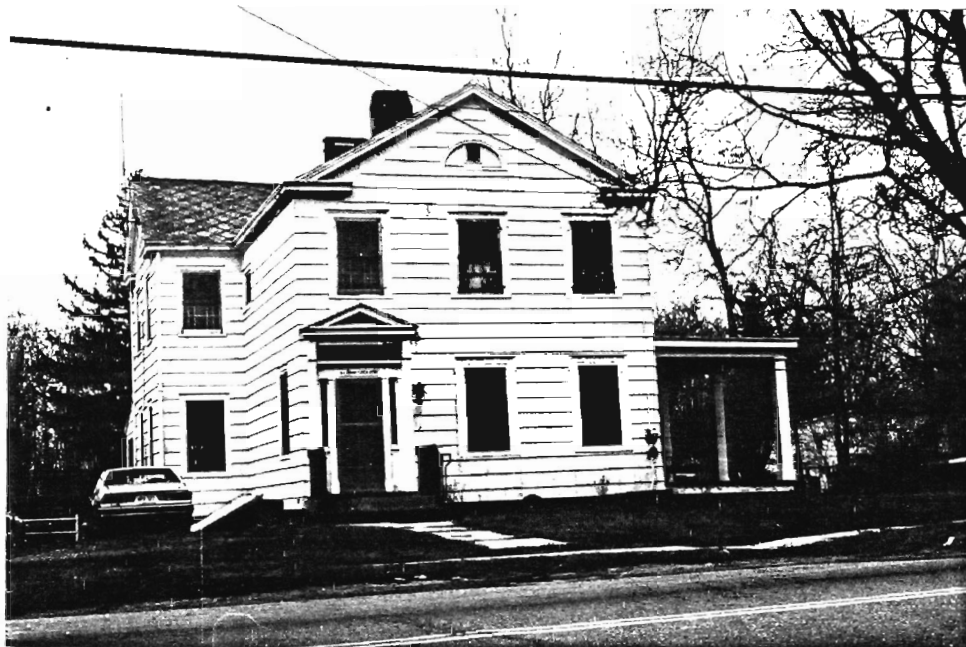
1328-1-5

9-9a N. Main St.; Block 90, Lot 8; Marlboro Quad; Neg. File No. 3-36. c.1830's-1840's frame Greek Revival residence. 2 story, 3 bay, T-plan. Gable roof with overhanging eaves and gable returns. 2 ridge chimneys. Wood shingle siding. 6/6 sash windows, semi-circular opening in gable peak. 6 panel door is in Greek Revival enframing with side and transom lights and a low pitched pediment. Brick foundation. Plaque on house dates house c. 1838. Owned by A.W. Hobart for much of the mid-19th c. He operated a dry goods, groceries and hardware store on the adjacent lot. He was also father of Garret A. Hobart, the Paterson politician and Vice-President under William McKinley.

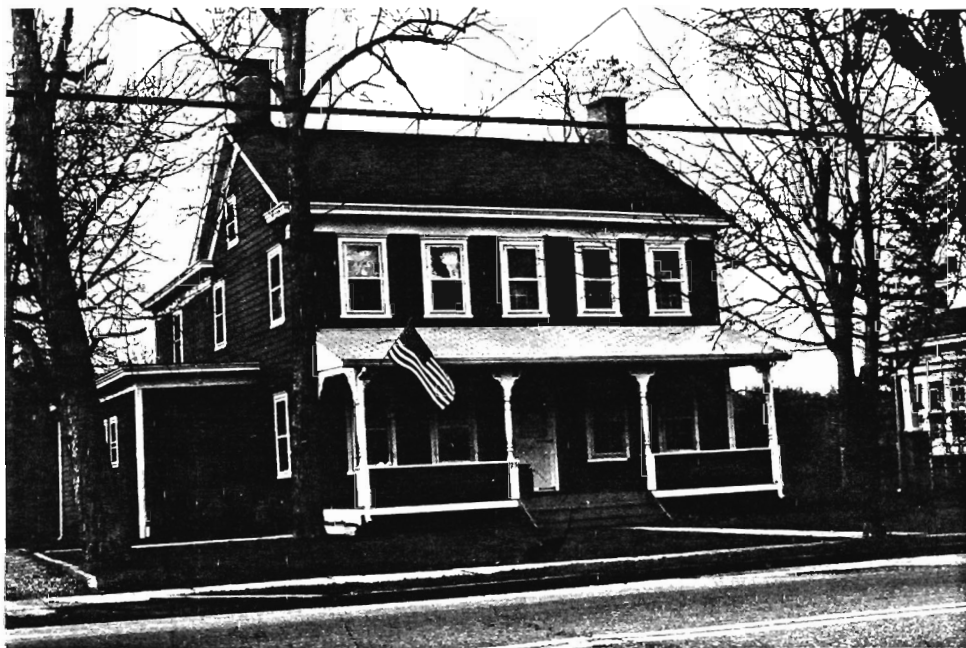
1328-1-6

23 N. Main St.; Block 91, Lot 5; Marlboro Quad; Neg. File No. 3-40. c. 1840's-1850's frame residence with Greek Revival elements. 2 story, 5 bay rectangular form with rear wing and side ell. Gable roof has overhanging eaves with gable returns and two internal end wall chimneys. Clapboard siding. 6/6 sash windows with milled lintels. Doorway is surmounted by 3 light transom. Shed roof porch is supported by turned posts with punched brackets. Brick foundation. Ownership is difficult to determine from maps. J.R. Stout or Dr. W. F. Fair was owner in 1860 and R. Laird was owner in 1873. Plaque gives construction date of c. 1840.

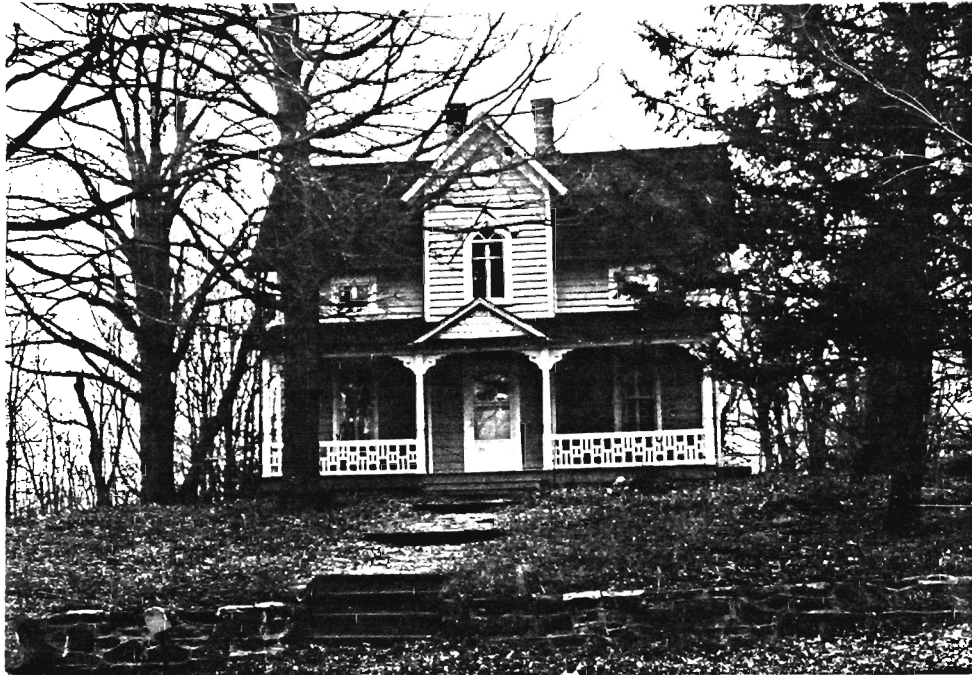
1328-1-7

38 N. Main St.; Block 95, Lot 11 B; Marlboro Quad; Neg. File No. 4-22*
 c. 1850's-1860's frame Gothic Revival residence. 2 story, 3 bay symmetrical T-plan. Center gable roof with two internal ridge chimneys. Clapboard siding. Pointed head window in projecting pavilion. Knee-wall windows in the second floor, full length 4/4 sash windows in first floor. Doorway is surmounted by two-light transom. Shed roof porch has a central pediment and is supported by turned posts with brackets. Balustrade has an unusual pattern. Brick foundation. Owned by W.E. Brewer in 1860, and by L. Holmes in 1873.

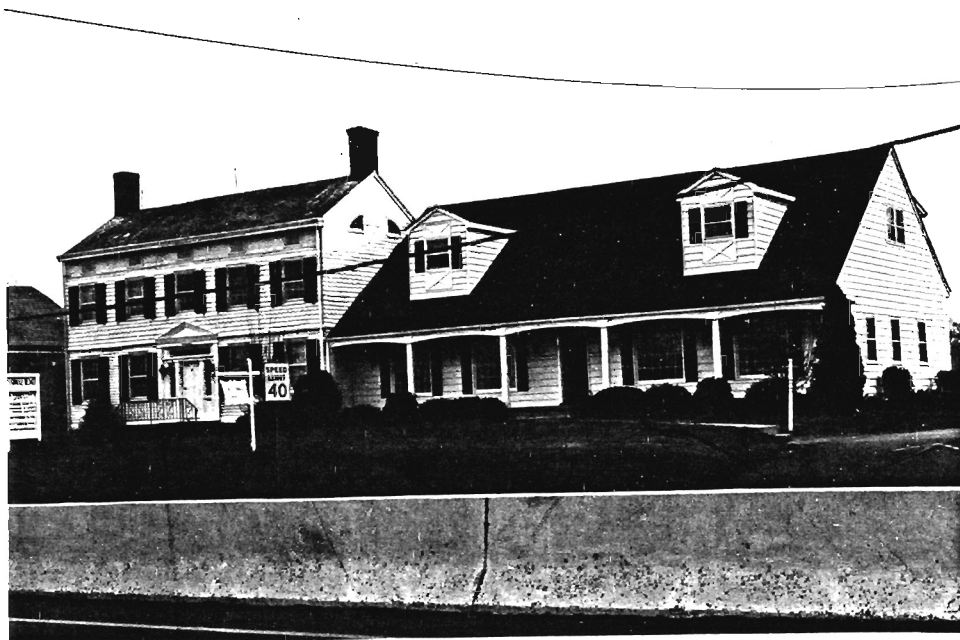
1328-1-8

9 S. Main St.; Block 71, Lot 4; Marlboro Quad; Neg. File No. 4-23,24.
 c. 1830's-1840's residence with Federal and Greek Revival elements and large 1960-1970's addition. 2½ story, 5 bay rectangular form (original section only) with rear ell. Gable roof has narrow eaves, simple box cornice and two internal end wall chimneys. Quarter fanlight flank chimney in gable ends. 6/6 sash windows, with knee-wall windows in third floor. Patterned shingle siding is late 19th century alteration. Doorway is in Greek Revival enframing with side and transoms lights surmounted by a low pitched pediment. Concrete veneer on foundation. Possibly owned by E.E. Brewer in 1851 and 1860, and by Mrs. S. Thompson in 1873 and 1889.

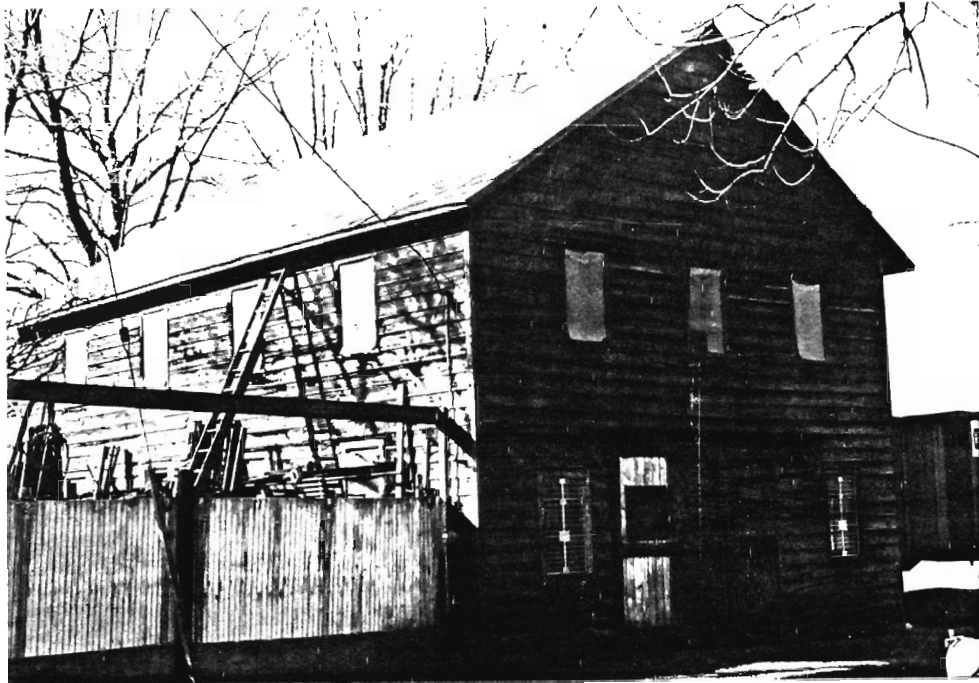
1328-1-9

Martin Collins Blacksmith and Wheelwright Shop

1910 frame blacksmith and wheelwright shop. 2 story, 3 bay by 4 bay form. Gable roof. Weatherboard siding. Windows are boarded up. Sliding double doors of unequal sizes. Brick foundation. Fenced in lot adjacent to building. Lot was the site of blacksmith and wheelwright shops throughout the 19th century.

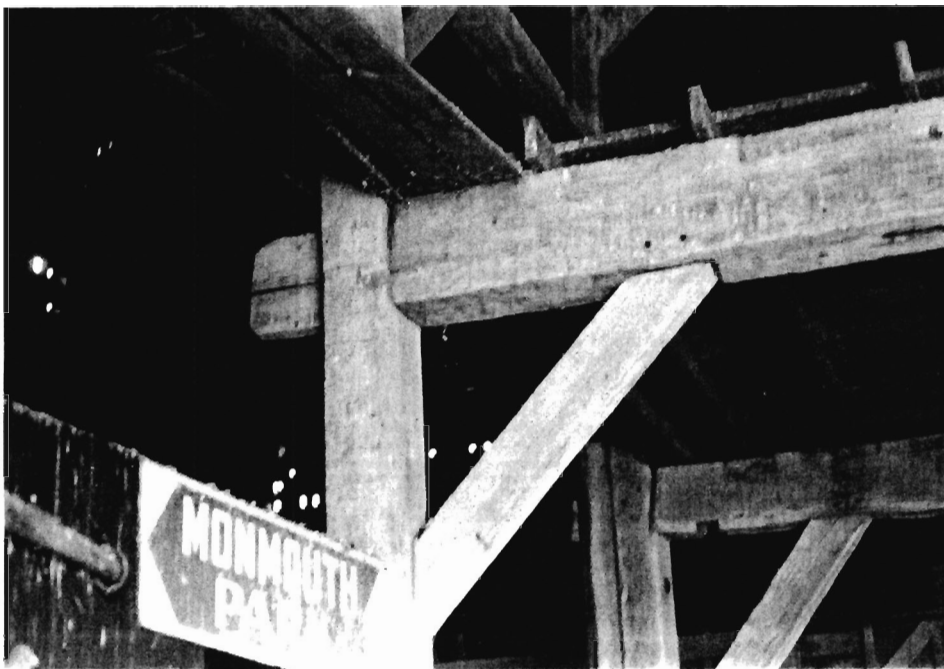
Barn (B), framing detail. 1981 photograph.

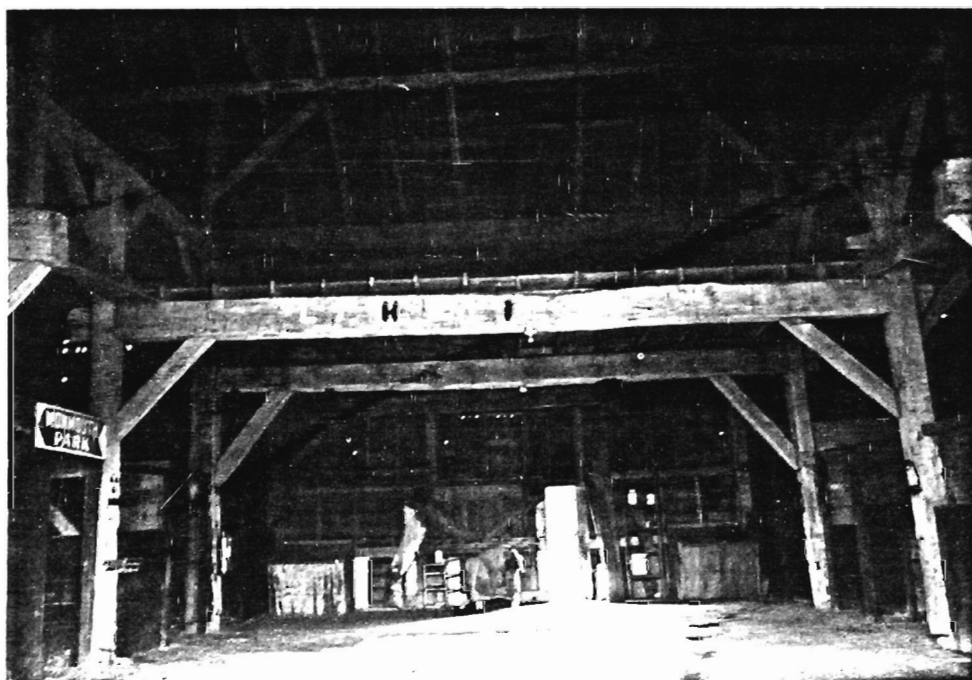
B. This barn was originally a Dutch barn. It has had its roof turned 90 degrees to resemble the form of an English barn. This is one of the largest barns of this type in the county. It has a very wide central aisle that is 4 bays deep, and two side aisles that are now used for horse stalls. The anchor beams are through tenoned as is typical of Dutch barns; the second anchor beam from the door has been removed at the braces, a potentially serious structural problem. The barn is built into a bank, the basement was probably used for cattle. A pentice is above the double door on the north wall. The wood shingle siding and the two cupolas date from the 20th century.

Barn B, framing detail.

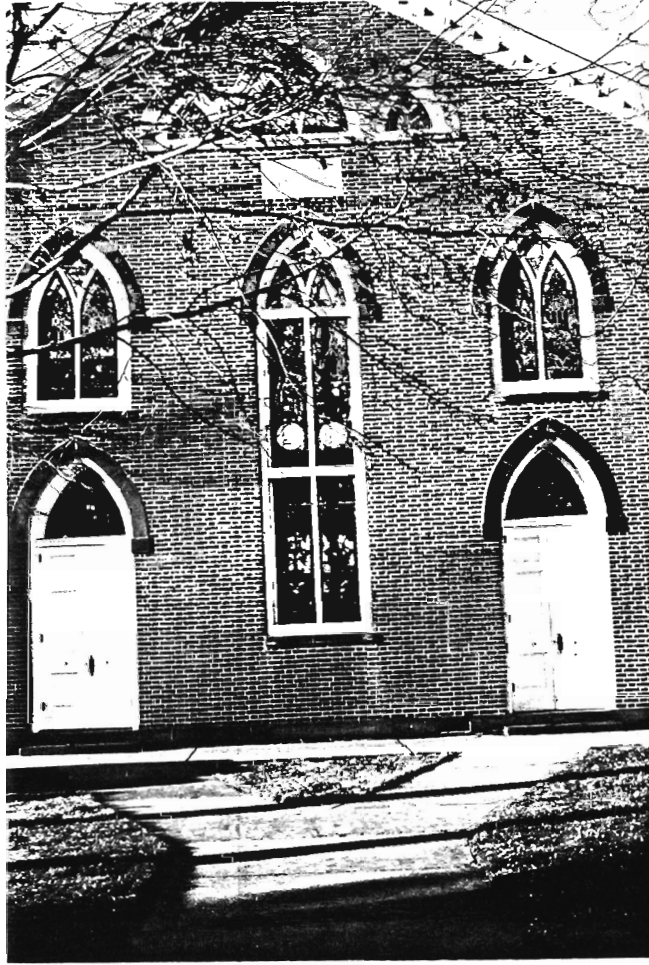
The church has a simple rectangular form; the Gothic Revival design elements are found primarily in the window and door treatments. The roof is moderately pitched, and has a scrolled modillion cornice with gable returns. An octagonal steeple on a square base with balustrade surmounts the roof peak. The lancet arch windows have brown sandstone lintels, as do the twin double doors with lancet arch transoms. The memorial windows were installed c. 1896.

Detail of front facade.

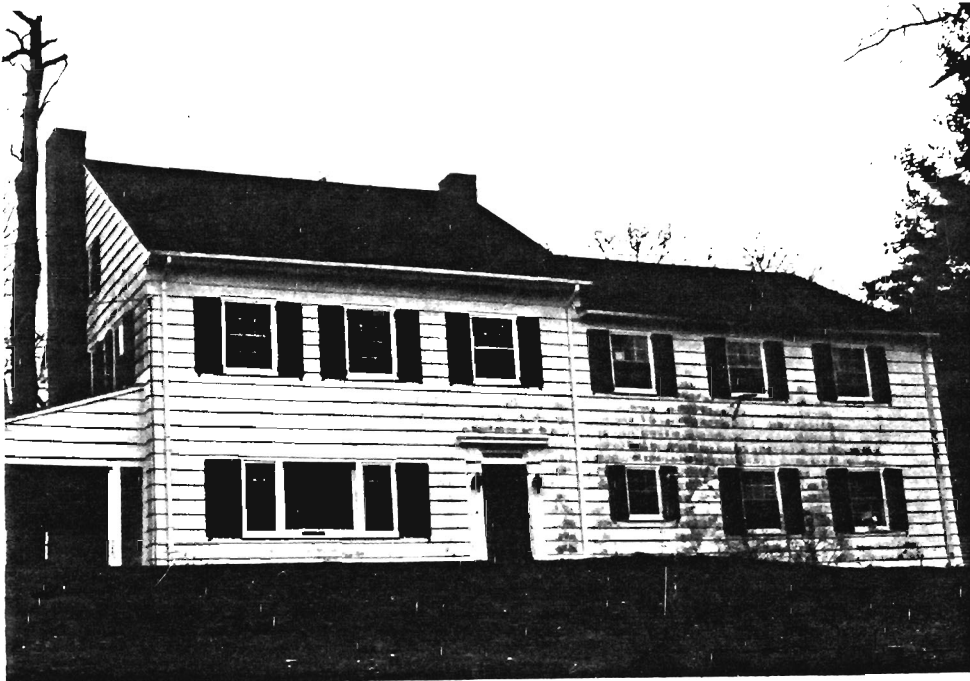
1328-5

S side Igoe Rd., 0.5 mi. W of Pleasant Valley Rd.; Block 40, Lot 18; Marlboro Quad; Neg. File No. 2-32 to 37.

Late 18th-early 19th century frame residence with farm buildings. 2½ story, 3 bay main block with west side 2 story, 5 bay wing. Both sections have been subject to considerable alteration. Gable roof has narrow eaves and simple cornice. External chimney E end and another in the E end of the wing, abutting the main block. Asbestos shingle siding. 6/6 sash windows, with picture windows on both N and S facades. Most windows appear to be replacements. N facade doorway is in a Colonial Revival enframingent with a small transom light. S facade doorway is flanked by sidelights and is beneath a shed portico. Fieldstone and concrete foundation. Owned by J. Schenck in 1851; by D. Conover in 1860 and 1873; and by T. DuBois in 1889. View to S.

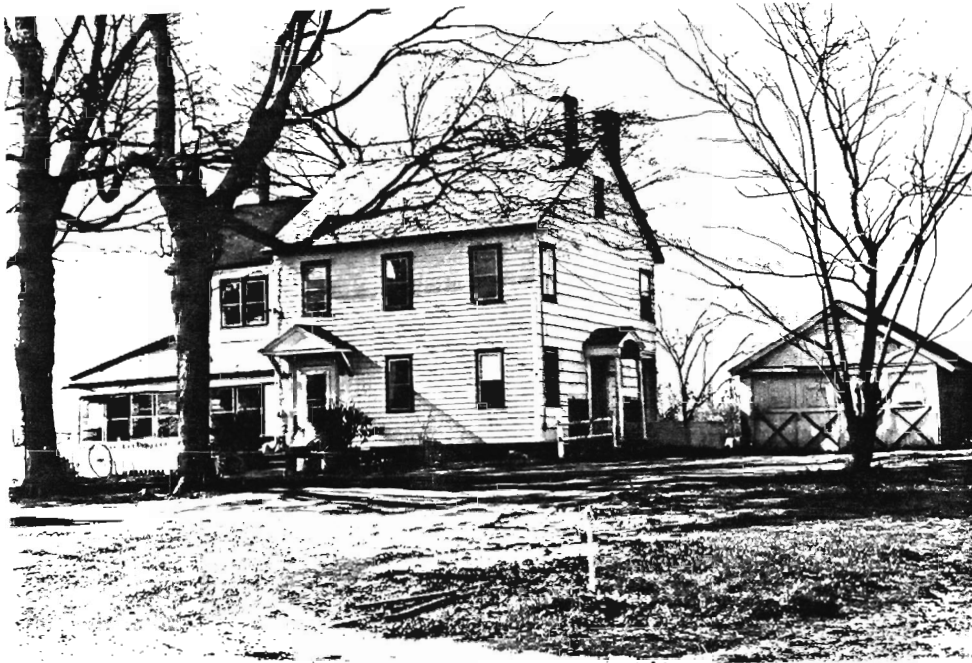
1328-7

N side Newman Springs Rd., 0.1 mi. E of State Highway 79; Block 44, Lot 18 A; Marlboro Quad; Neg. File No. Holmdel Roll 11-33,34,35.

Late 18th-early 19th century (main block) frame residence. 2½ story, 3 bay main block with 2½ story, 2 bay wing with lean-to. Main block has a gable roof with slate roofing and twin end wall chimneys with exposed hearth-backs. Wood shingle siding. Windows are in simple surrounds with 3/1 light sash. Doorway has side and transom lights that have been painted over and is beneath a gable overdoor. Wing is difficult to date due to alterations and additions, it may predate the main block. It has a gable roof with a pedimented west end and lean-tos on the south and west sides. The property was the Parsonage for the Dutch Reformed Church (1328-10) until sold in 1826 when the Freehold and Middletown congregations divided. Daniel P. Conover was owner in 1873 and in 1885. View to NW.

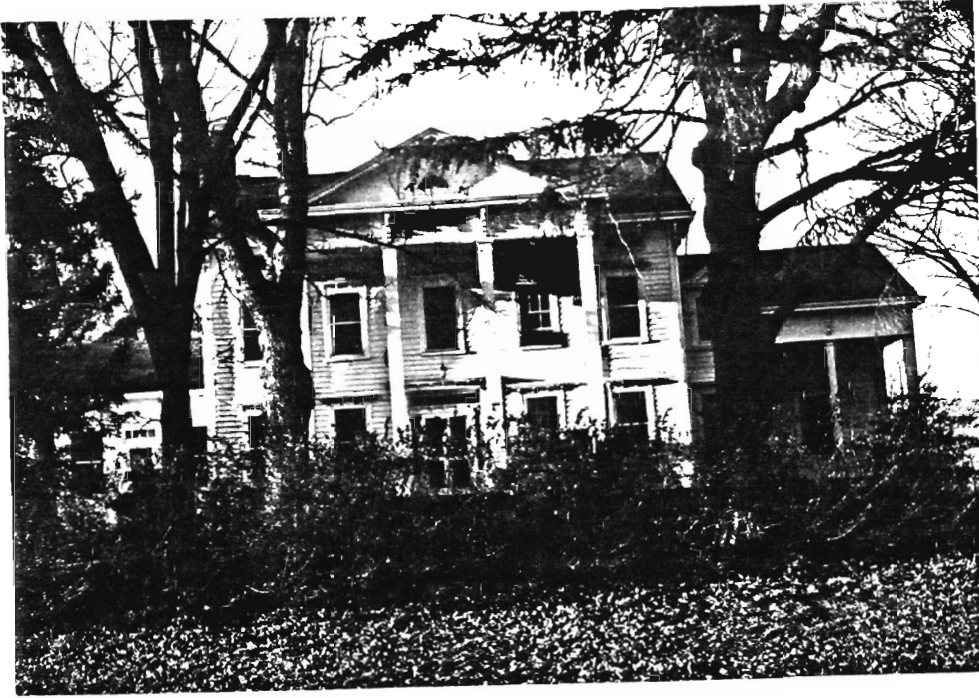
1328-12

164 Newman Springs Rd.; Block 42, Lot 4; Marlboro Quad; Neg. File No. 3-31,32. Between 1860 and 1873 frame Italianate residence. 2½ story, 5 bay main block with flanking 1½ story, 2 bay wings. Gable roof has bracketed overhanging eaves with gable returns and a 3 bay 2 story portico with full pediment supported by squared columns. 6/6 sash windows have bracketed lintels. Double front doorway is flanked by sidelights and surmounted by a 4 light transom and bracketed cornice. Slate roofing. Twin end wall chimneys on west end of main block. Clapboard siding. Brick foundation. Owned by E. Brown in 1873 and by A. W. Vanderveer in 1889.

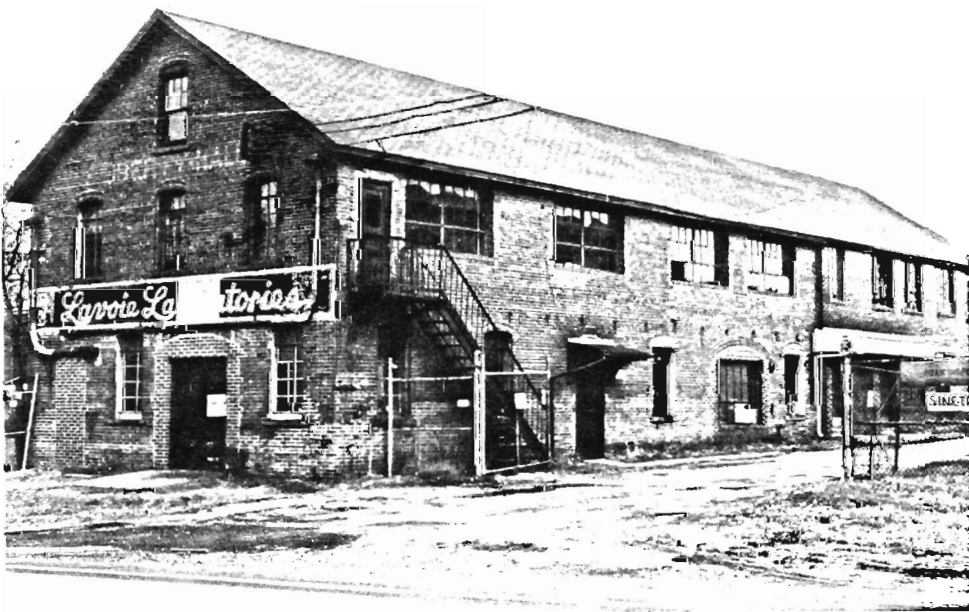
1328-22

E side State Highway 79, 2 N of Beacon Hill Rd.; Block 26, Lot 12; Keyport Quad; Neg. File No. 4-9. Late 19th-early 20th c. brick blacksmith shop. 2 story, 5 bay long rectangular plan. Gable roof. Original windows (examples on front facade) were under segmental arches and had 5 light casements. Side wall fenestration has been altered with installation of large windows. Doorways have been reduced in size. "LIBERTY HALL" (earlier) and "LaVoie Laboratories" (later) have been painted on the front facade.
